Docket No. 217 – Development and Management Plan Inspection

Northeast Utilities Service Company Certificate of Environmental Compatibility and Public Need for the construction of a 345-kV electric transmission line and reconstruction of an existing 115-kV electric transmission line between Connecticut Light and Power Company's Plumtree Substation in Bethel, through the towns of Redding, Weston, and Wilton, and to the Norwalk Substation in Norwalk, Connecticut.

Date: February 16, 2006

Location: 345kV Underground Route

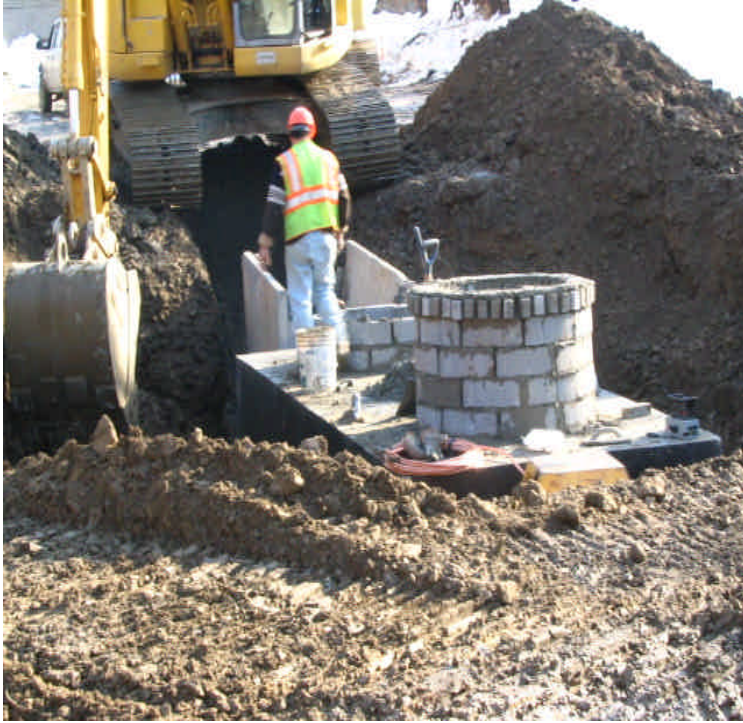
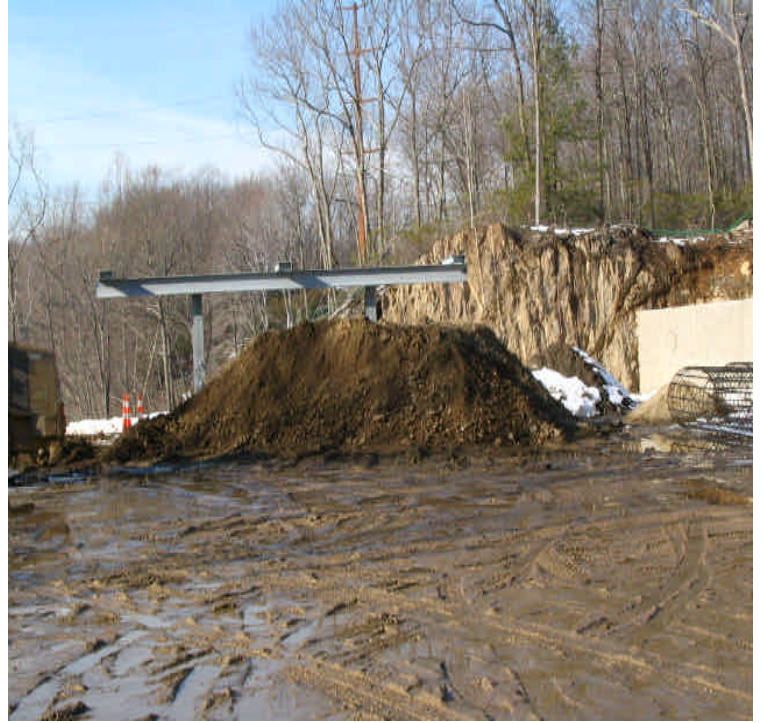
345kV (Archers Lane): Both photos show the vault operation in the Archers Lane station yard. Soil is stockpiled but remains within the pad and dewatering has not been necessary for the work. 2/16/06

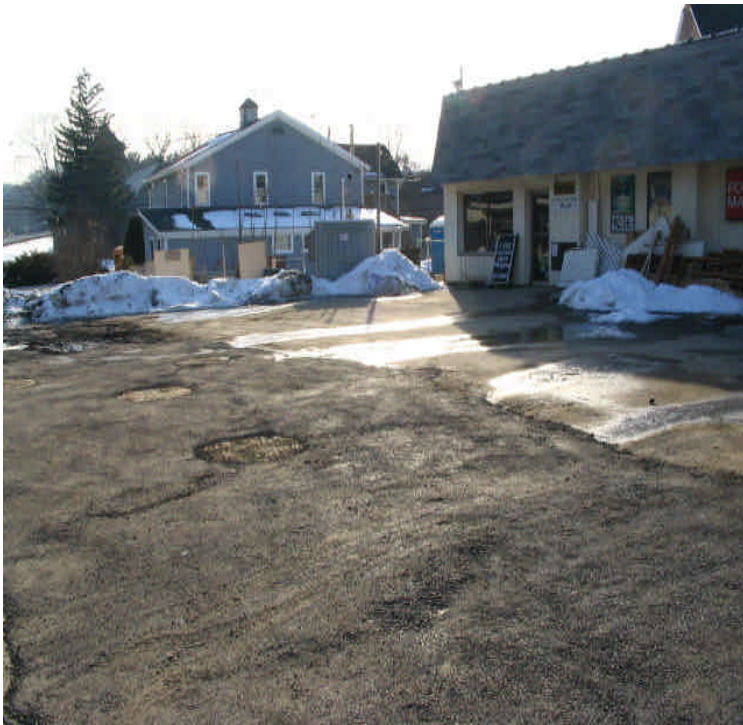
(Georgetown Deli and Rt. 7): Photo on the left shows the parking lot at the Georgetown Deli. Work internal to the vault was not noted and the parking lot had been paved. Photo on the right shows the Racquet Club storage. Haybales should be installed in a swale here. 2/16/06

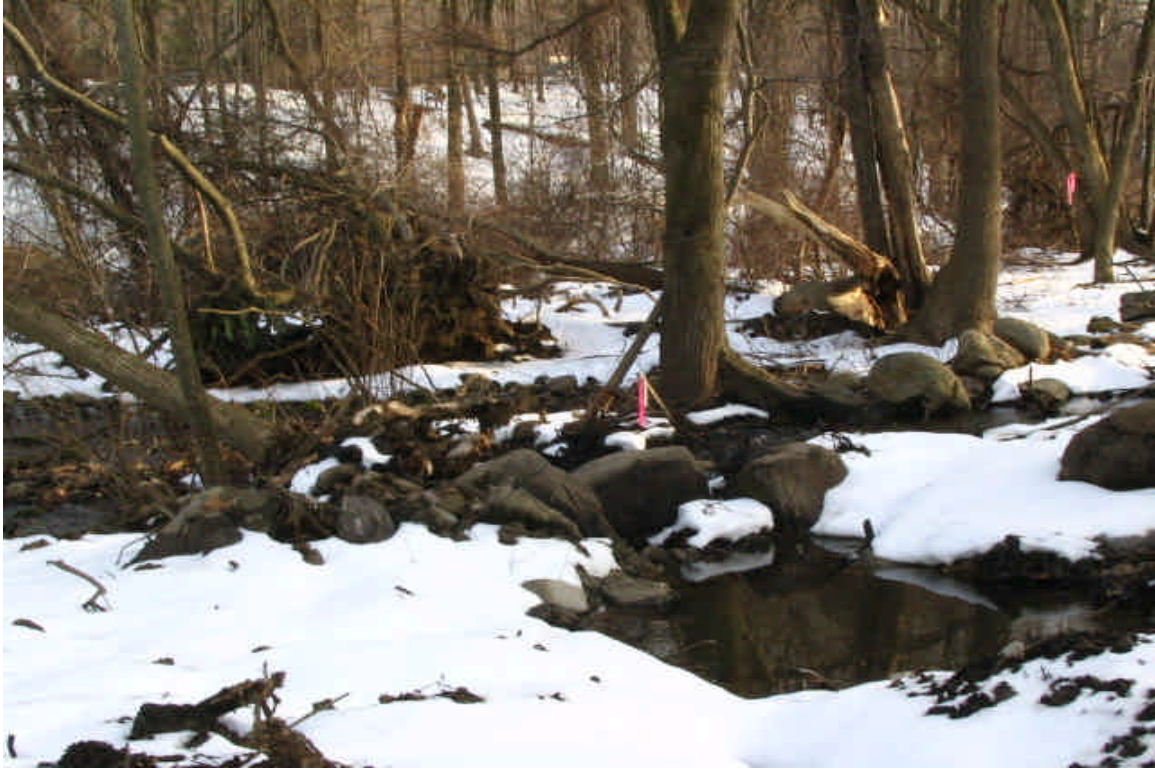
345kV (HDD) Photo shows the wetlands beyond the basin where the excavator recently accessed to repair a breakout in the bore hole. As a result several trees were knocked down or broken and an area was disturbed in order to contain the muds. 2/16/06

<p>Adjacent Wetlands and Waterways</p>	<p>-At the jack and bore near Allens Meadow Park, the outlet slope will need final restoration. 1/19-2/16/06</p> <p>-The breakout described at the HDD resulted in direct access and impact to the wetland beyond the basin in order to contain the muds. This also resulted in disturbed soil in the wetlands. 2/9-2/16/06</p> <p>- Wetlands directly to the east of the basin will have to be evaluated after the work is complete. 1/19-2/16/06</p> <p>-Combination of non-project related offsite dewatering and issues with controlling the muds has led to sedimentation to the wetlands past the controls and check dams</p>	<p>-It is probably best to leave the sediment in the stream alone at this point. Plan to remove stone and haybales and instream controls for final restoration. 1/19-2/16/06</p> <p>- A restoration plan should be implemented for the wetlands potentially including plantings in the spring. In the meantime, the soil surface needs stabilization or controls. 2/16/06</p> <p>-Reducing sources of turbidity on site will likely help with this issue. Restoration may also be necessary here.1/19-2/16/06</p> <p>- When conditions are stable, sediment will need to be carefully removed by hand. 2/16/06</p>

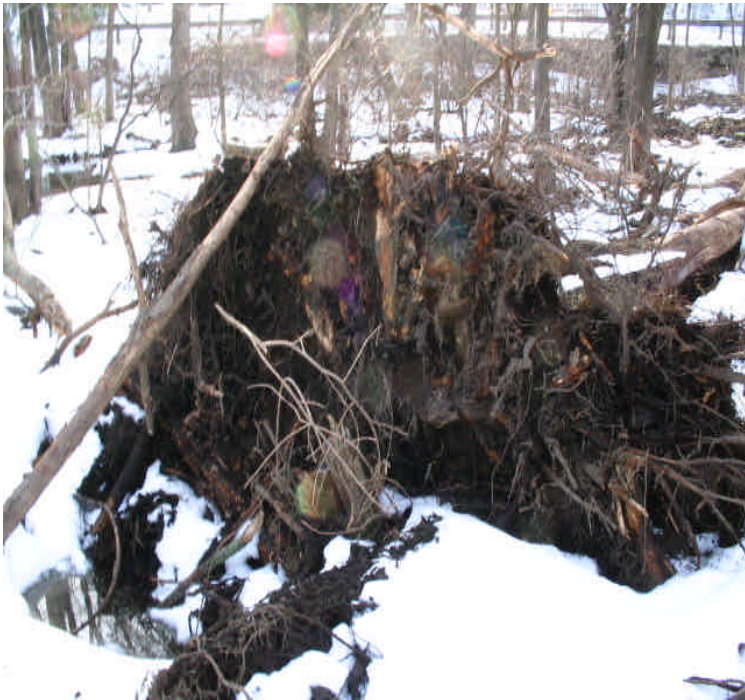
Photo on the left shows one of the trees that was either blown down or knocked over by equipment movement. A restoration plan should be considered. Photo on the right shows the wetlands beyond the basin where sediment accumulation has occurred beyond the haybales. 2/16/06

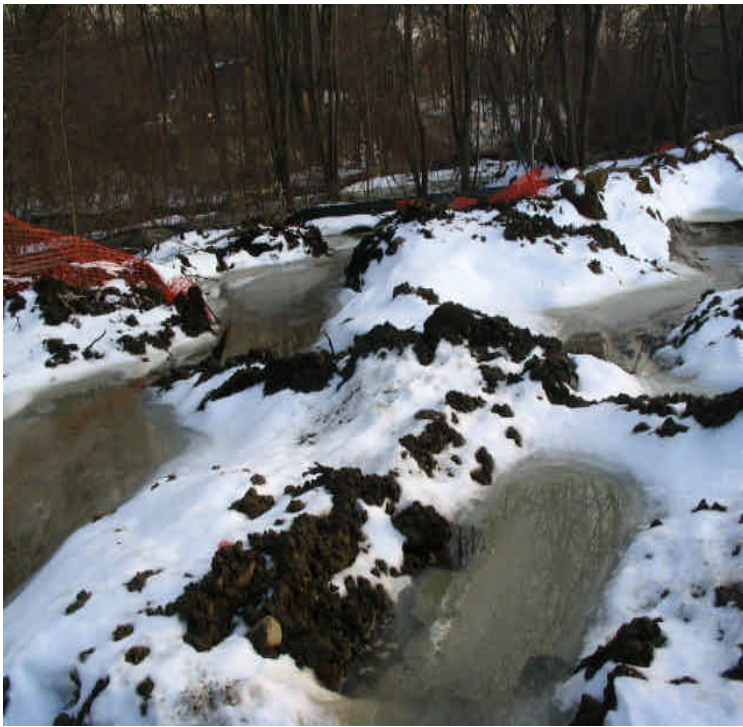
Photo on the left is a view of the eastern side of the basin. Some of the muds from the site are migrating to this area. Photo on the right shows where turbid water is pooling up and getting through the controls, causing the sediment accumulation in the wetlands. This is from a combination of off-site non project related dewatering as well as the on-site muds. 2/16/06

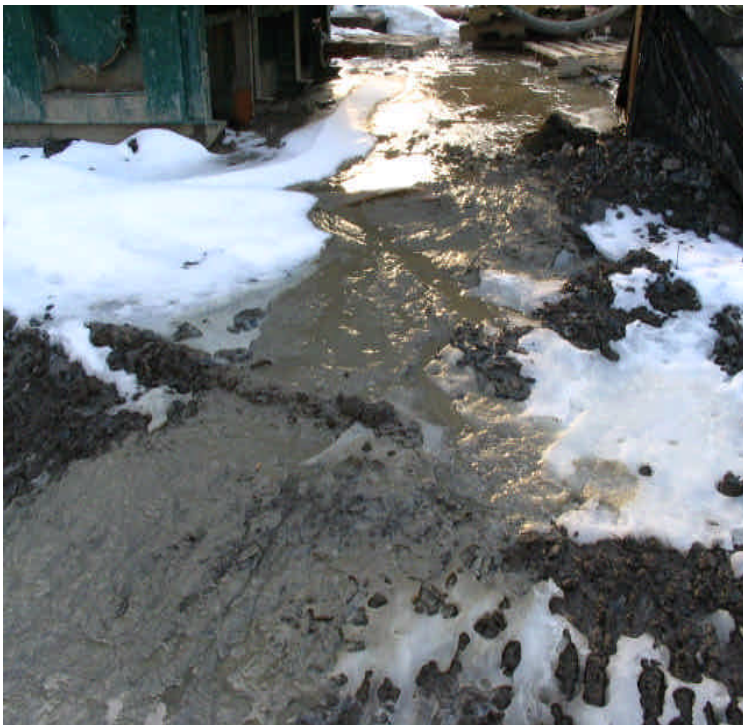
Photo on the left shows where muds are again escaping the area below the baker tank. Some of the flow returns to the basin but the remainder is ending up at the eastern side of the basin and creating turbidity issues. Photo on the right shows additional leaks under equipment. 2/16/06

Blasting	<p>- No blasting is occurring on site at this time.</p>	<p>- None at this time.</p>
Spills and Material Storage	<p>- The turbid washwater and sediment containment issues at the HDD are returning to some degree. Some berms or repair of controls may help this situation again. 2/16/06</p> <p>A contingency plan should also be considered if a significant storm is predicted. 1/19-2/16/06</p> <p>- A tarp remains under a leaking piece of equipment and the refueling tank but additional leaks were noted beyond the tarp where the stone was affected. Absorbent pads here were also becoming saturated. 2/16/06</p>	<p>- The basin is being excavated of mud but larger stabilization/source control measures should be examined. 1/19-2/16/06</p> <p>- Frac tanks will be brought in if necessary. 2/16/06</p> <p>-Another tarp is needed to extend the containment and pads were going to be replaced. Affected stone should be removed. 2/16/06</p> <p>Continue to monitor and maintain plastic as needed. Dispose of properly at completion. 1/19-2/16/06</p>

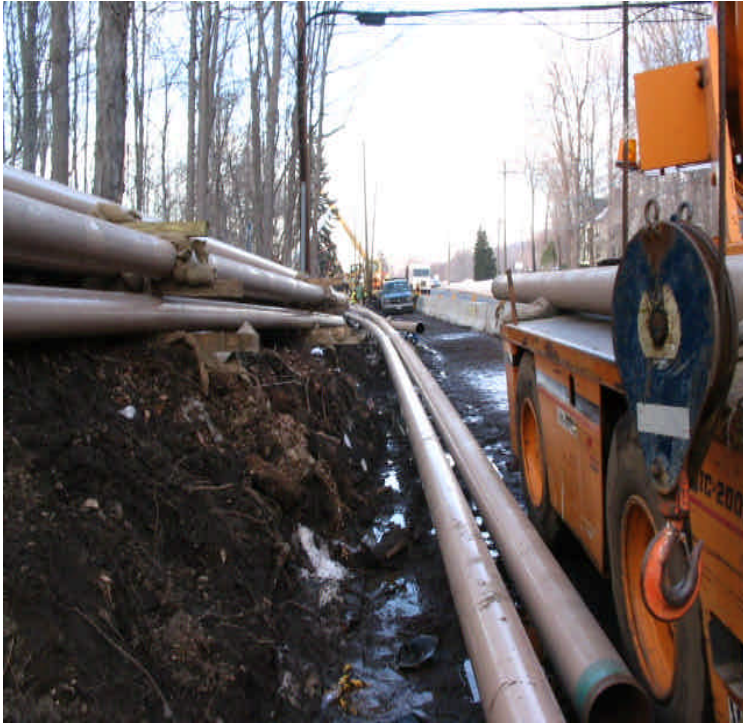
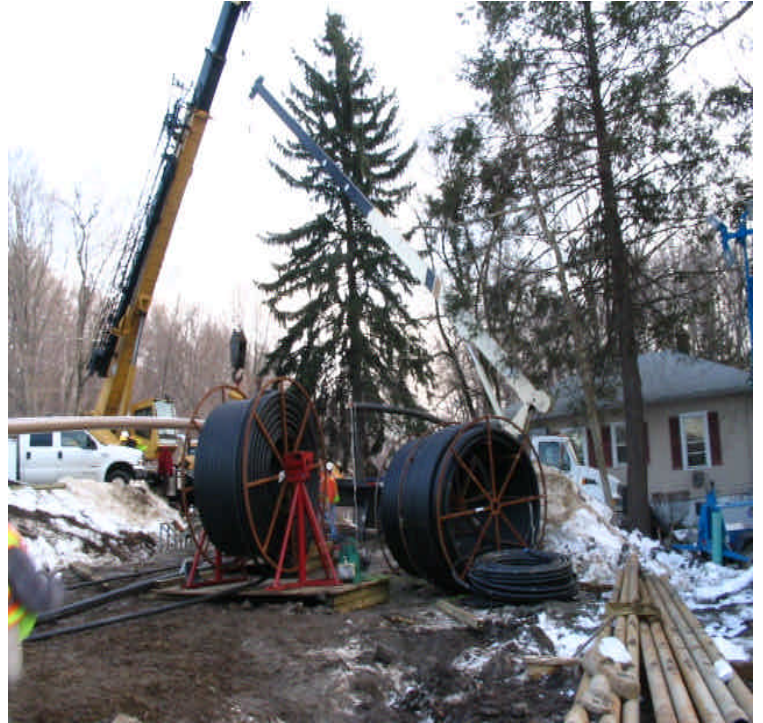
345kV (HDD exit): Photo on the left shows the pipe set up and ready to be pulled into the bore hole. Photo on the right is a view of the bore exit point where the operation to install the utilities in the bore is ongoing. 2/16/06

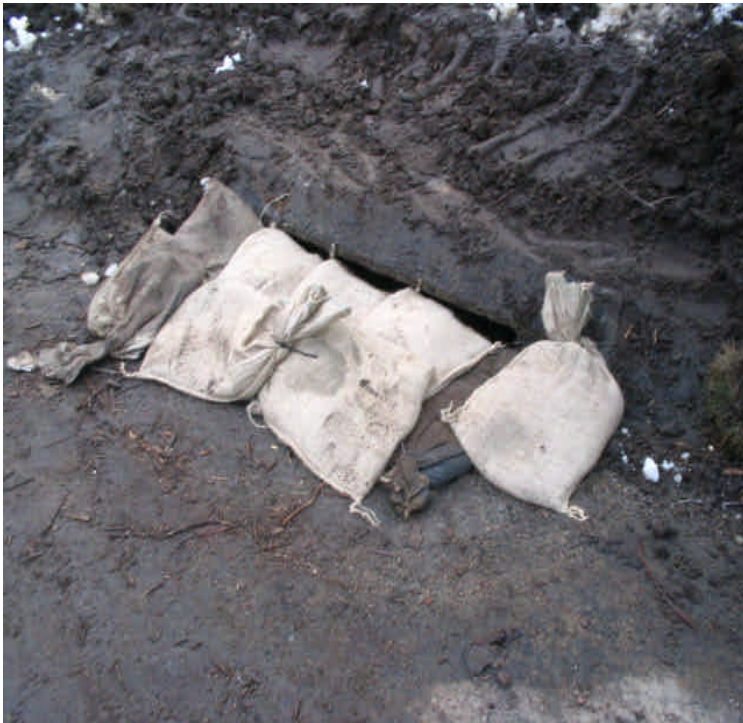
345kV (Rt. 7): Photo on the left is a view of a catch basin that was protected immediately after it was noted without controls. Photo on the right is an overview of the trenching along Rt. 7 in the vicinity of Orem's Lane. 2/16/06
